92 Washer solvent level warning is on

92 19 23 2038151/10 November 12, 2019. Supersedes Technical Service Bulletin Group 92 number 19-17 dated February 7, 2019 for reasons listed below.

Model(s)	Year	VIN Range	Vehicle-Specific Equipment
All	2012 - 2021	All	Not Applicable

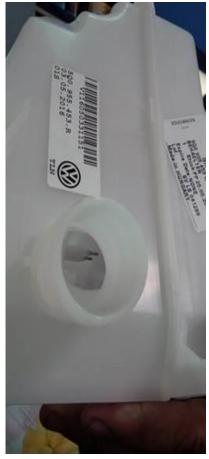
Figure 2. Windshield washer level sensor probes as viewed through the tank opening.

For Audi A3 Sedan and A3 Cabriolet where the washer solvent level sensor is not removable the sensor probes can be cleaned by removing the reservoir, removing the filler neck from the reservoir and gaining access to the sensor probes (Figure 2).
